Application Note AN # 77

Contactless analysis of mural paintings with a new portable FT-IR analyzer

Surface analysis of mural paintings by Francesco Albani in Bologna, Italy (End of XVI century)

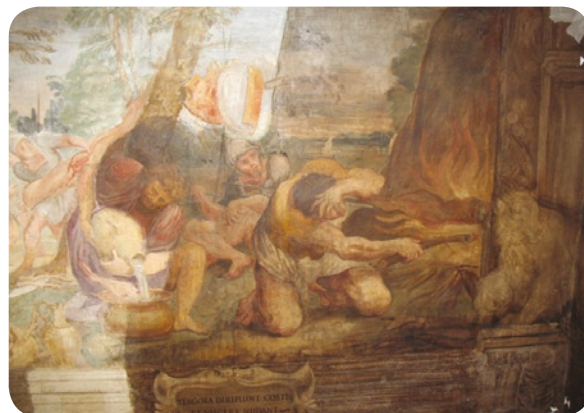
Figure 1: Mural painting by Francesco Albani in Bologna, Italy, during restoration process ^[1].

The ALPHA FT-IR spectrometer proved its high potential during the restoration of mural paintings by Francesco Albani in Bologna, Italy (Figure 1 and 3). Selected areas of the mural paintings were analyzed before and after cleaning in order to decide on the best cleaning method and solvent or if the treatment is really effective. The spectra collected directly on the surface of the mural painting were compared to reference spectra from the library.

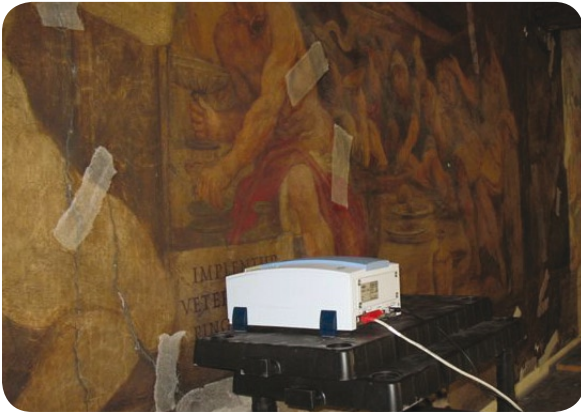
Figure 2: The ALPHA, equipped with a dedicated reflection module, is placed in front of the mural painting to perform the FT-IR measurements.

As the ALPHA is insensitive to vibration, it can be placed almost anywhere, can be moved, and is immediately operational without any need for alignment. Equipped with a front-reflection module, which is designed for contactless and non-destructive FT-IR measurements, the portable ALPHA was placed in front of the mural painting (Figure 2). The ALPHA can also be placed on a tripod, the measurement position can be adjusted accordingly (Figure 8). In addition, the ALPHA's battery and wireless options enable extra portability features.

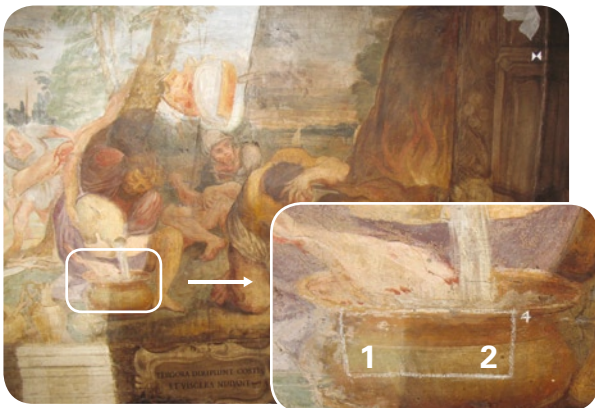
Figure 3: Detail of the mural painting during restoration process. Area 1: after cleaning; area 2: before cleaning.

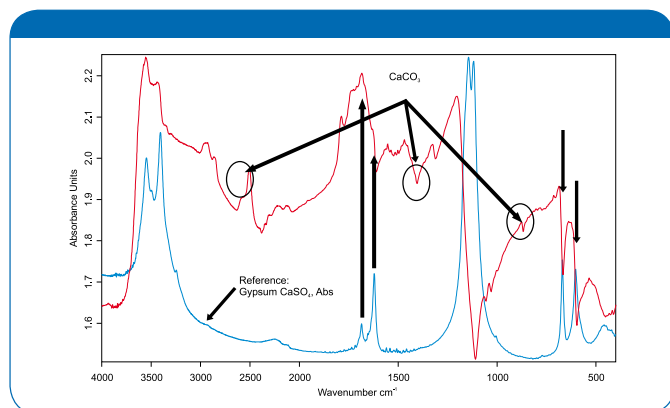
Figure 6: Spectrum (red) of the mural painting after treatment with acetone and comparison with a calcium sulfate reference (blue). Calcium sulfate and calcium carbonate are identified.

In addition, comparing the spectra of the treated mural painting with a spectrum reference for calcium sulfate (gypsum) from the library identifies the calcium sulfate and calcium carbonate (Figure 6).

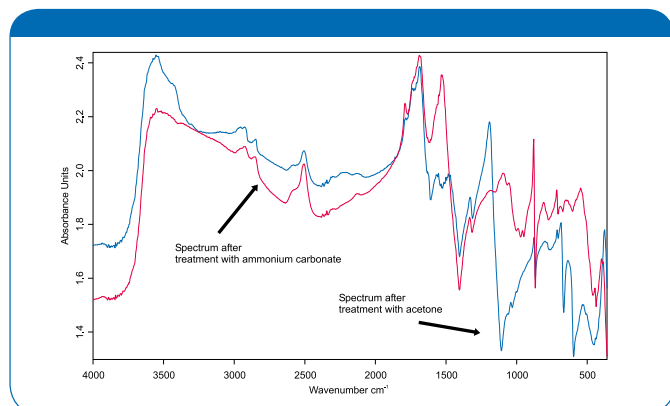
Figure 7: Spectrum of the mural painting after treatment with ammonium carbonate (red). Calcium sulfate was removed successfully. For comparison, the spectrum after treatment with acetone is displayed (blue).

Subsequently, one part of the mural painting was treated with ammonium carbonate to remove the calcium sulfate. Figure 7 shows the successful treatment on the mural painting surface by the ammonium carbonate treatment; no absorbance peaks of calcium sulfate can be identified after this treatment step.
